RAILROAD AVENUE PHOTO LOG

**RIO TINTO
LEGACY MANAGEMENT**

SUTHERLANDS PHOTO LOG

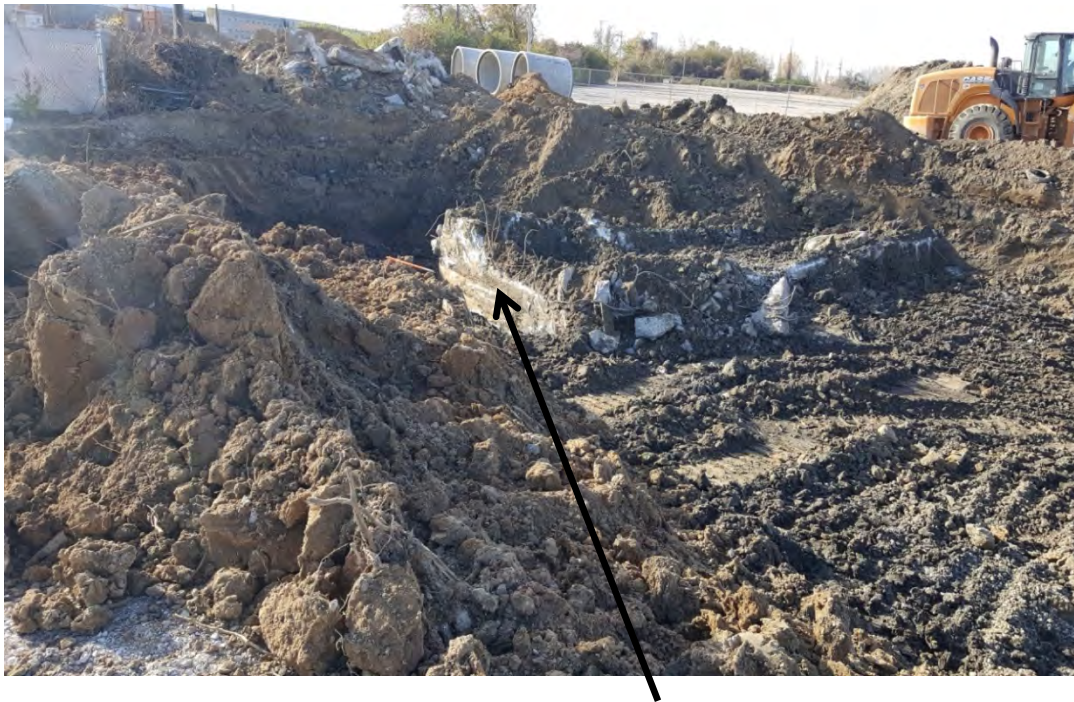
Excavation continues south sump discovered

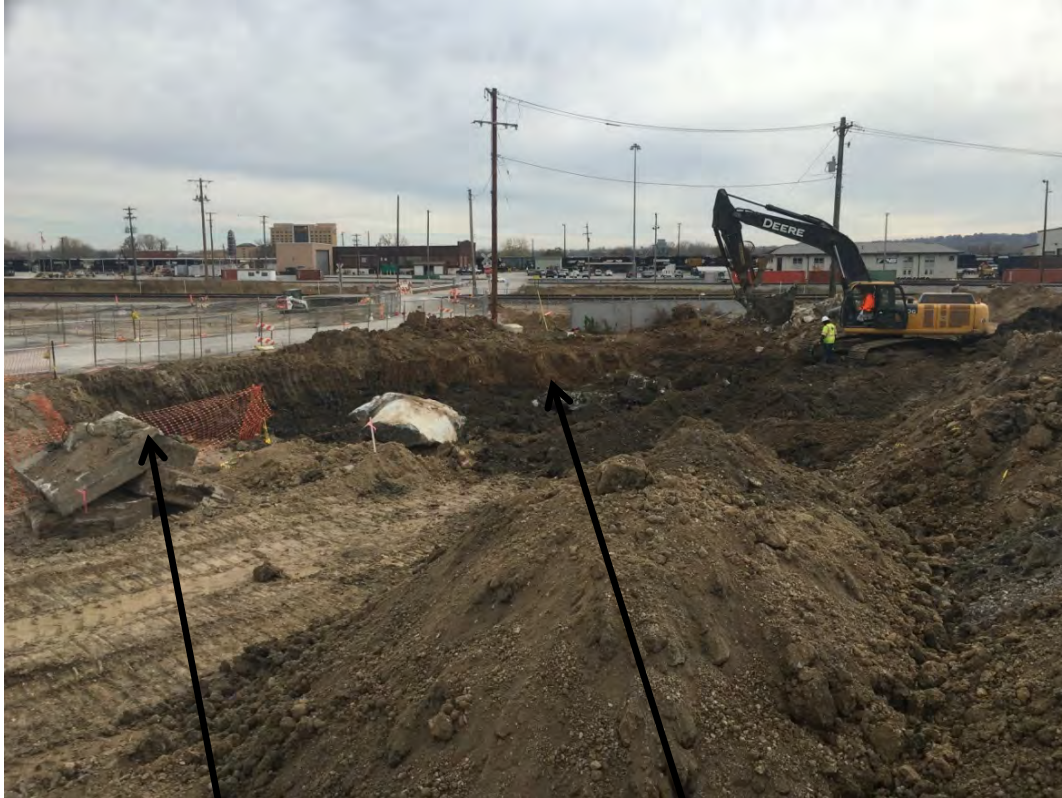
Found old footings near sump

Sump being removed

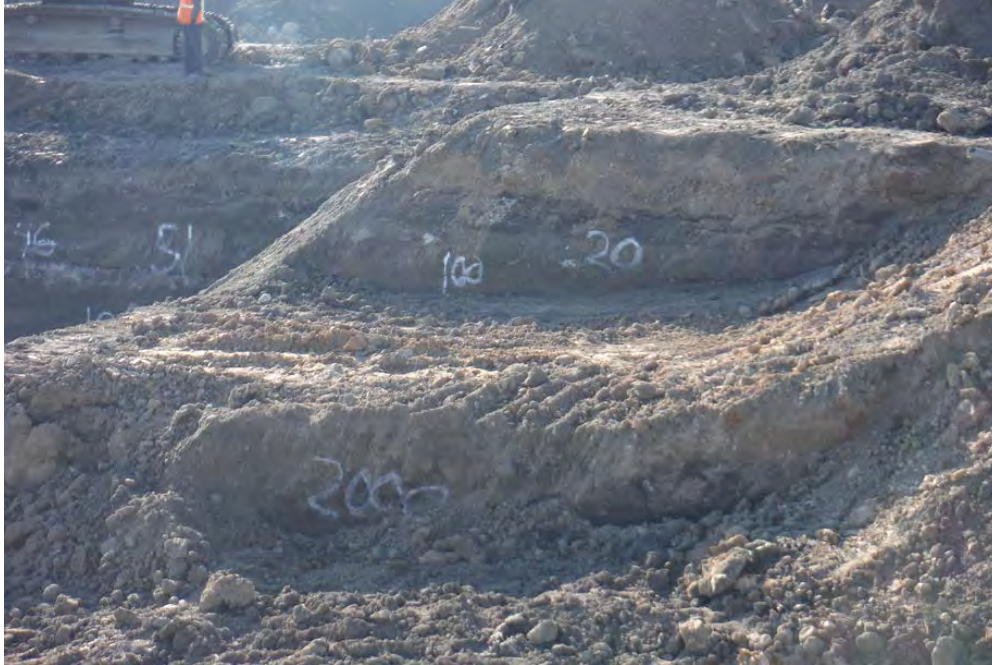
Bench cuts west of the sump excavating to clean soil

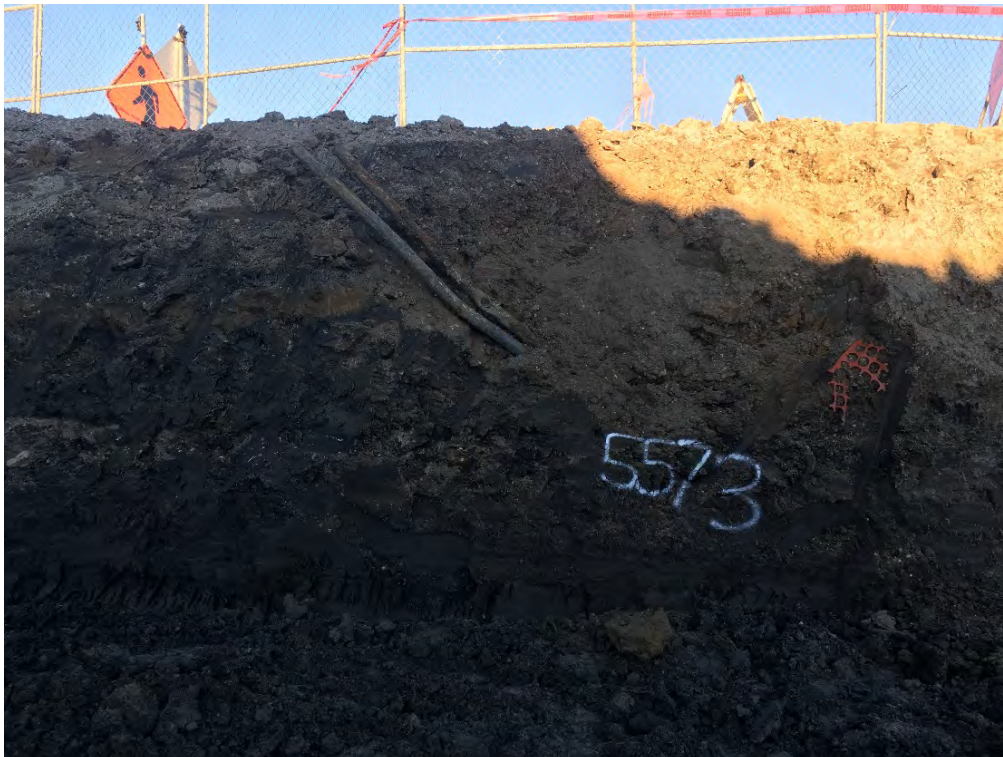
Excavation continues north along the HABCK/Sutherlands property lines. Old piping found. Light brown soil is loess fill from 2006, dark soil is native soil being removed

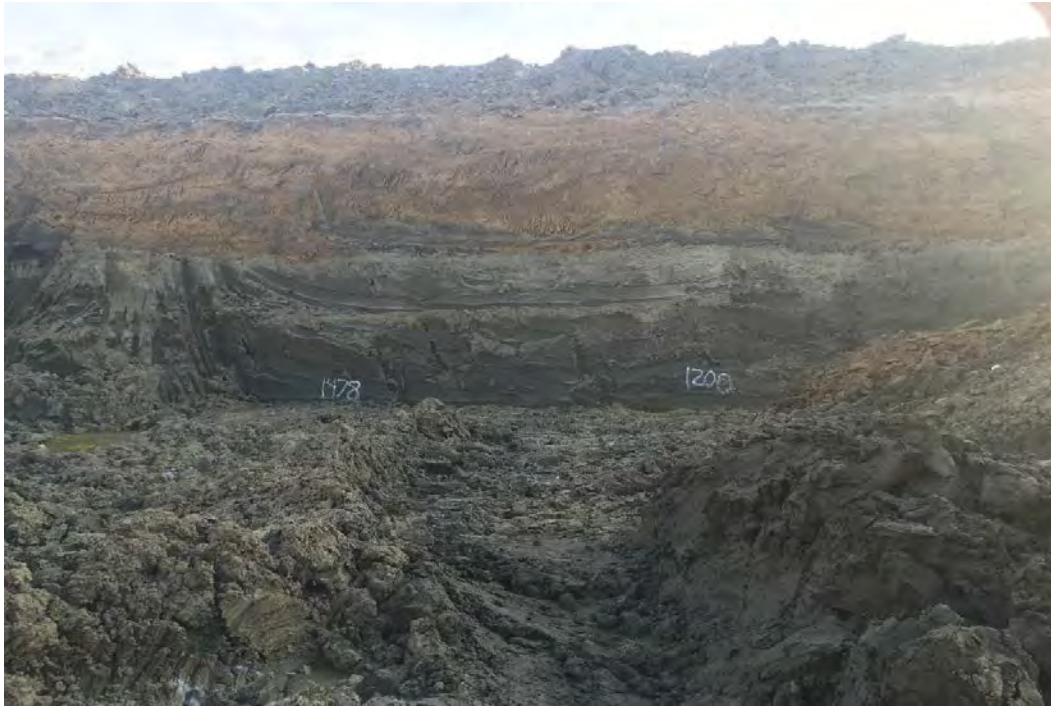
Excavation along the HABCO/Sutherlands property line. Brown soil is clean fill from 2006, dark soil is being removed.

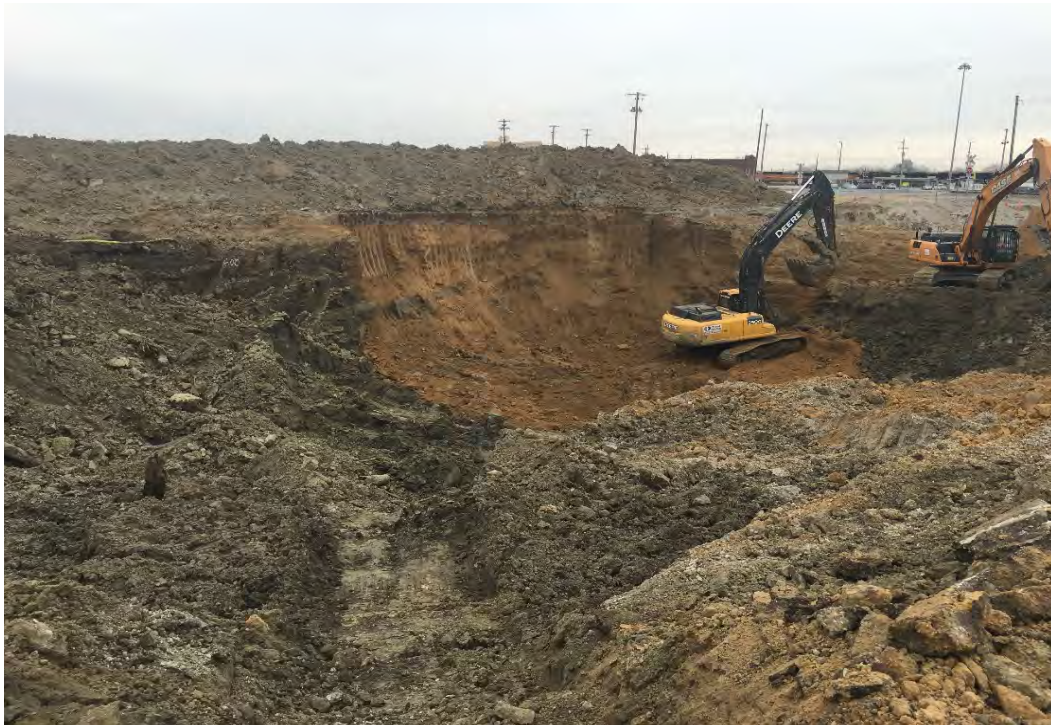
Dark contaminated soil being complete removed to reveal clean backfill from 2006 RA

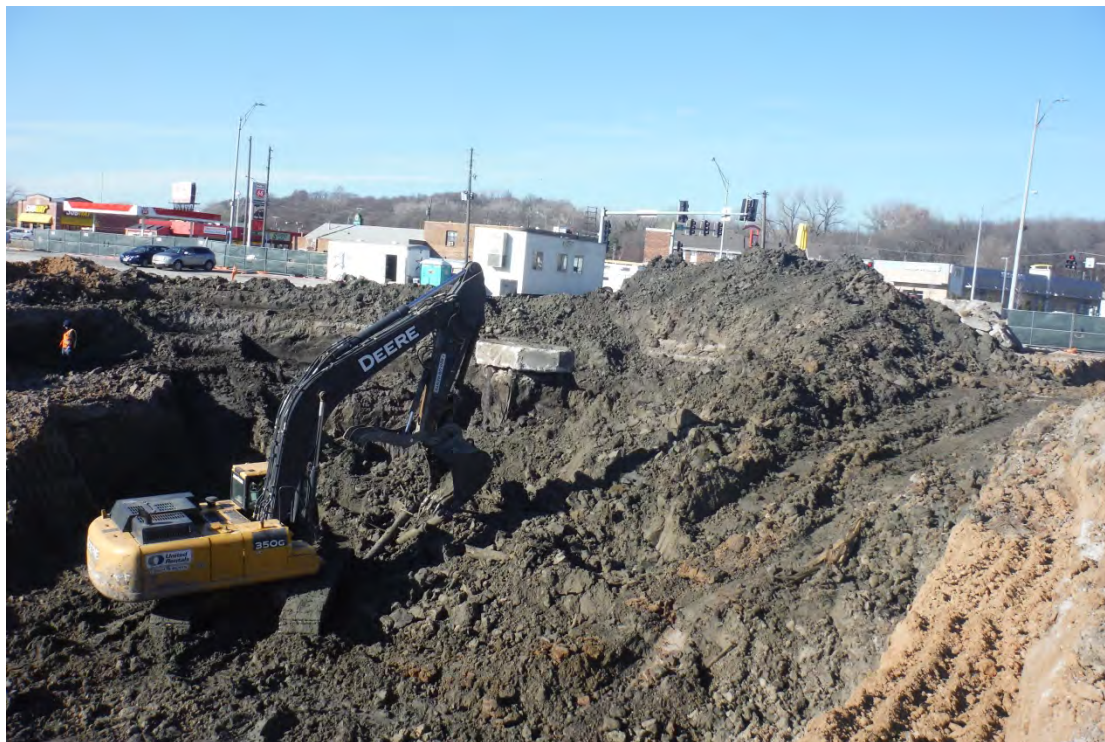
Excavation around the old foundations

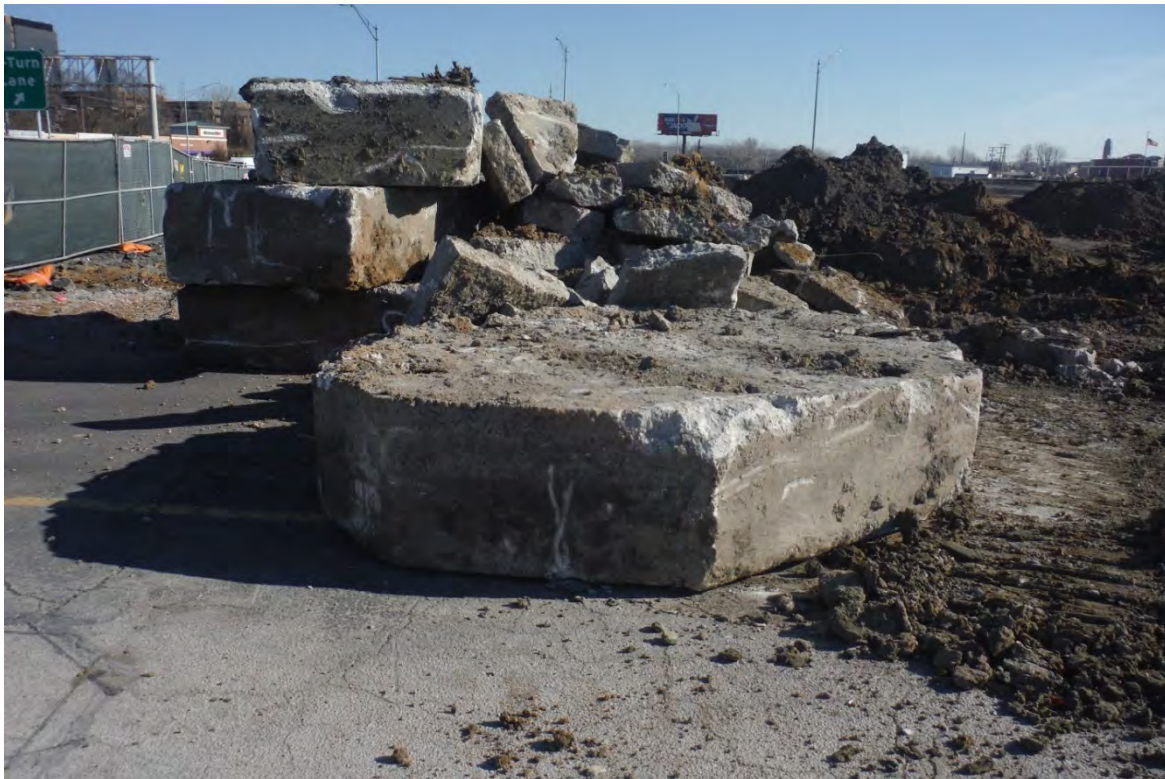
Foundation slabs temporarily removed to allow further excavation

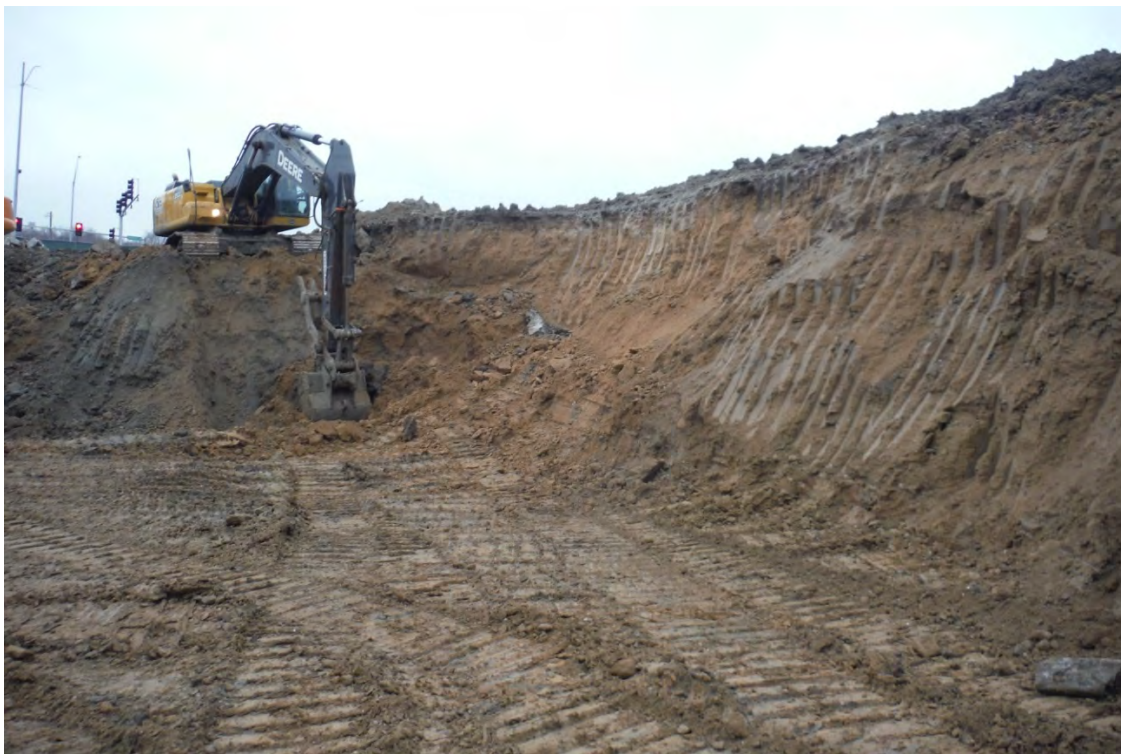
East wall excavation continues past the old foundations revealing clean fill from the 2006 RA

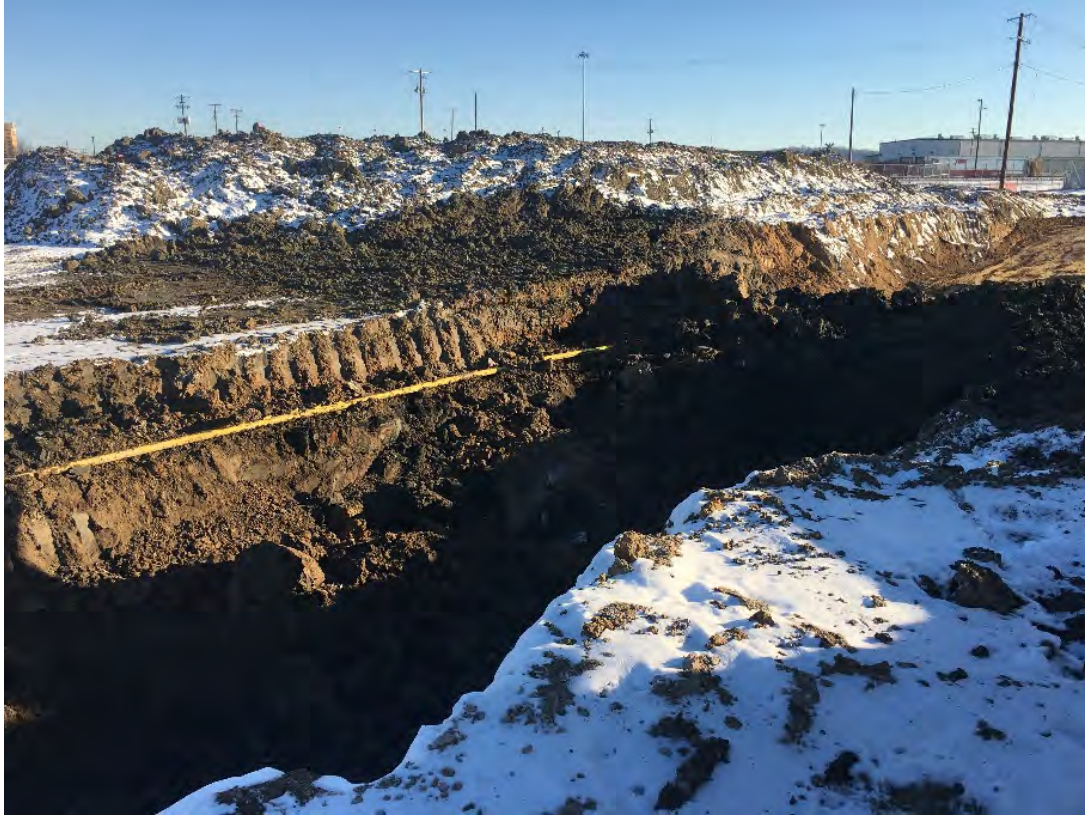
Excavation reveals the out-of-service natural gas pipe

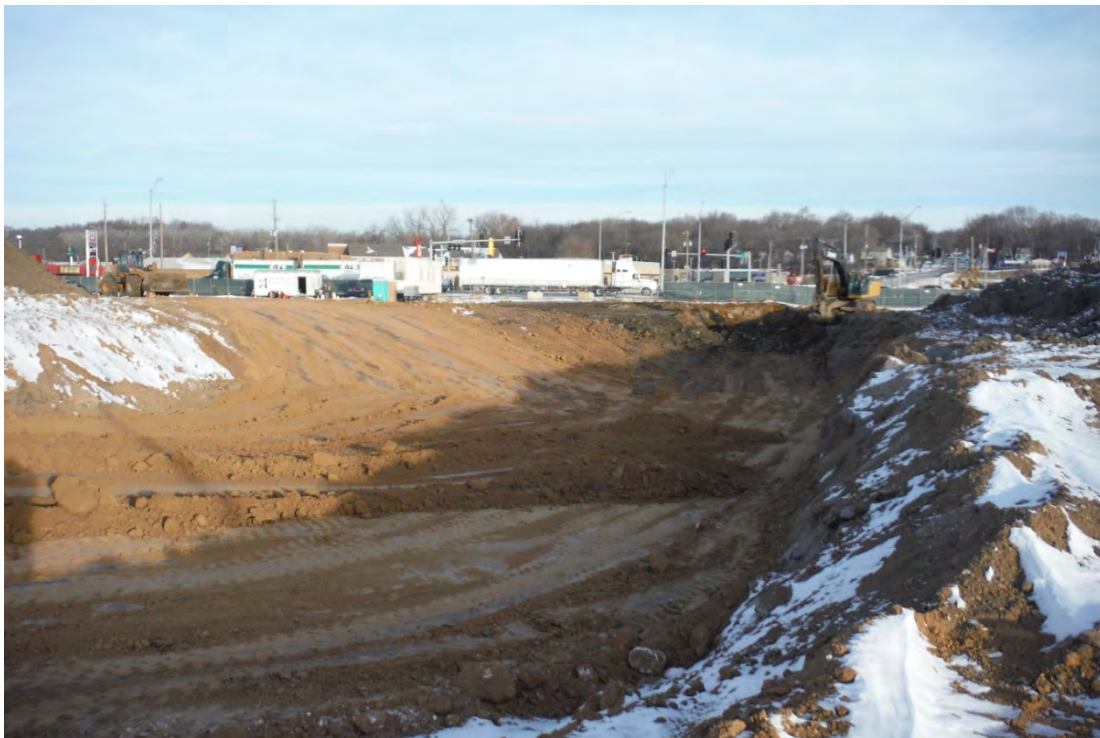
Sutherlands excavation being backfilled

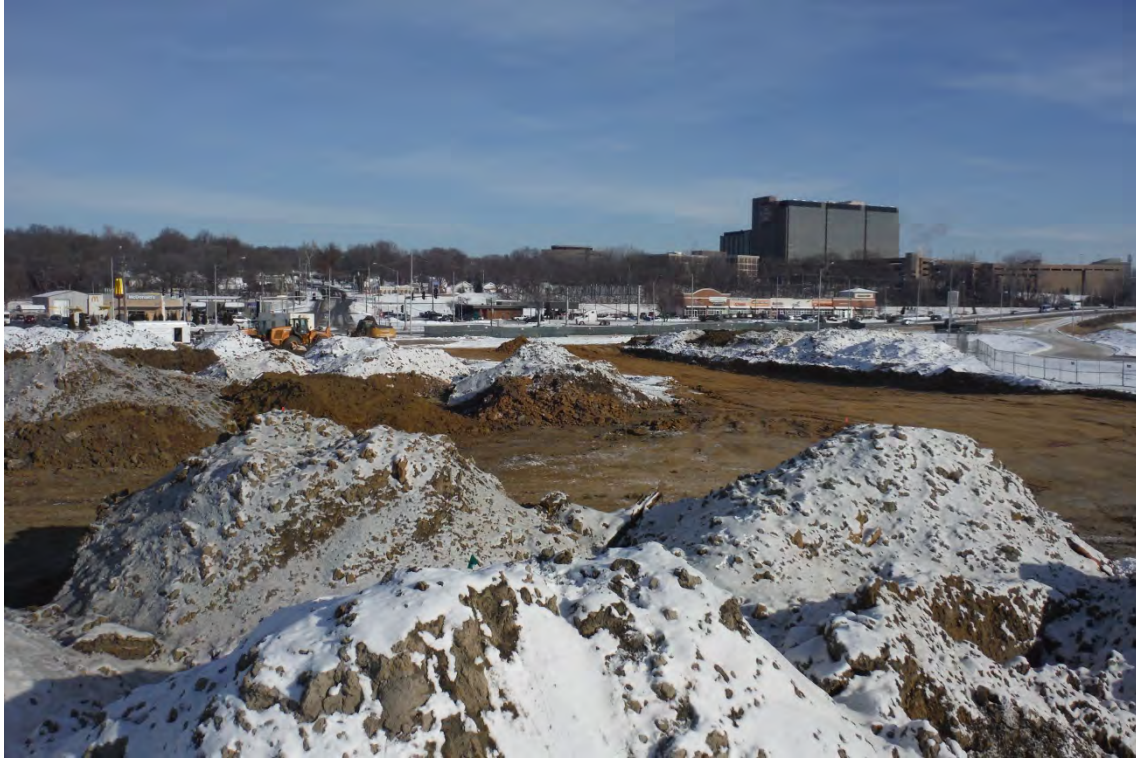
Sutherlands soil management area, backfilled excavation in the background

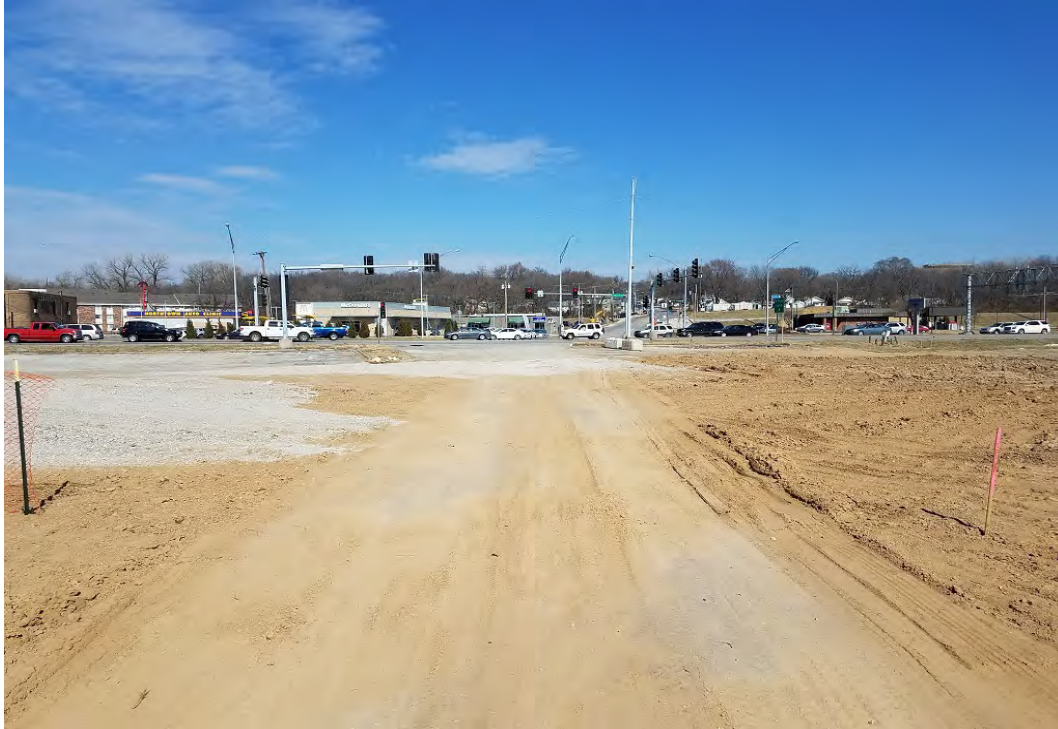
Demobilization complete, view north, Sutherlands on left; RR Ave on right

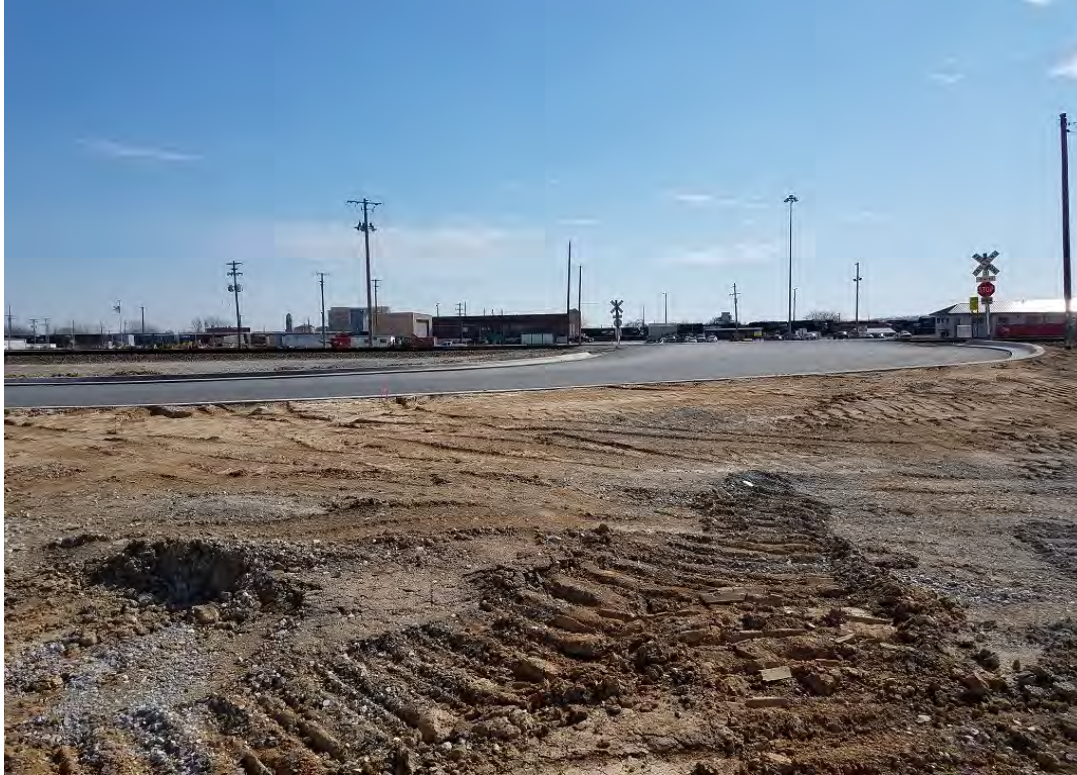
West end of the RR Ave excavation, road rebuilt

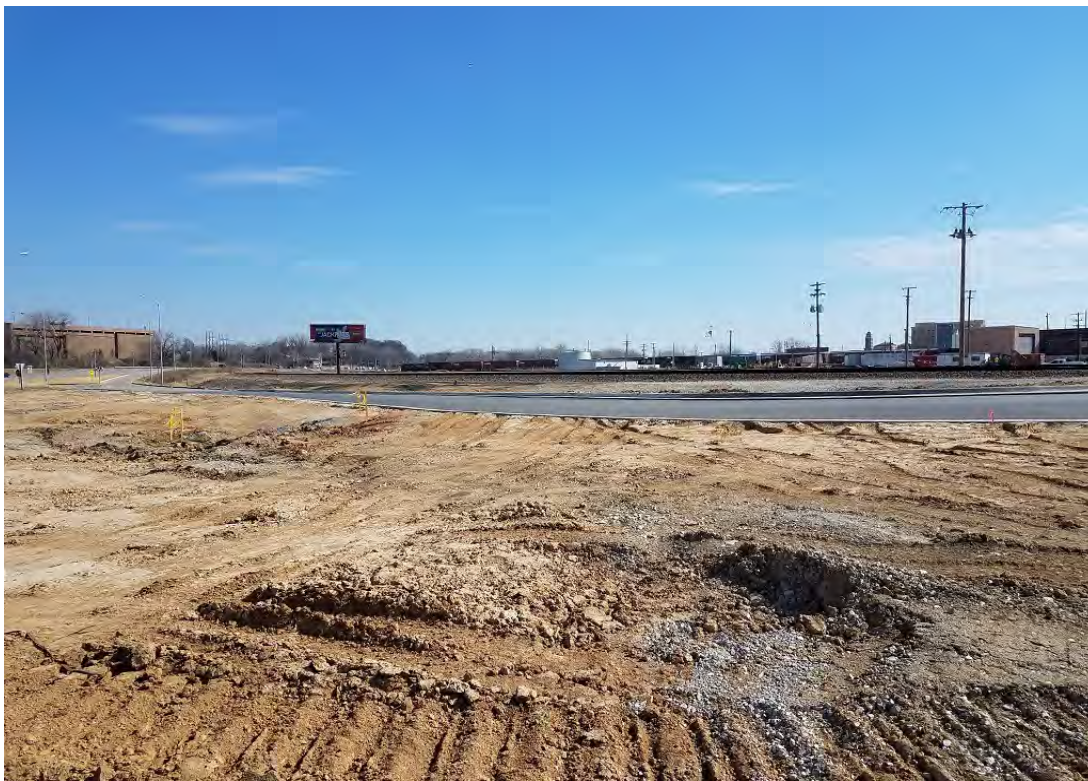
East end of the RR Ave excavation, road rebuilt

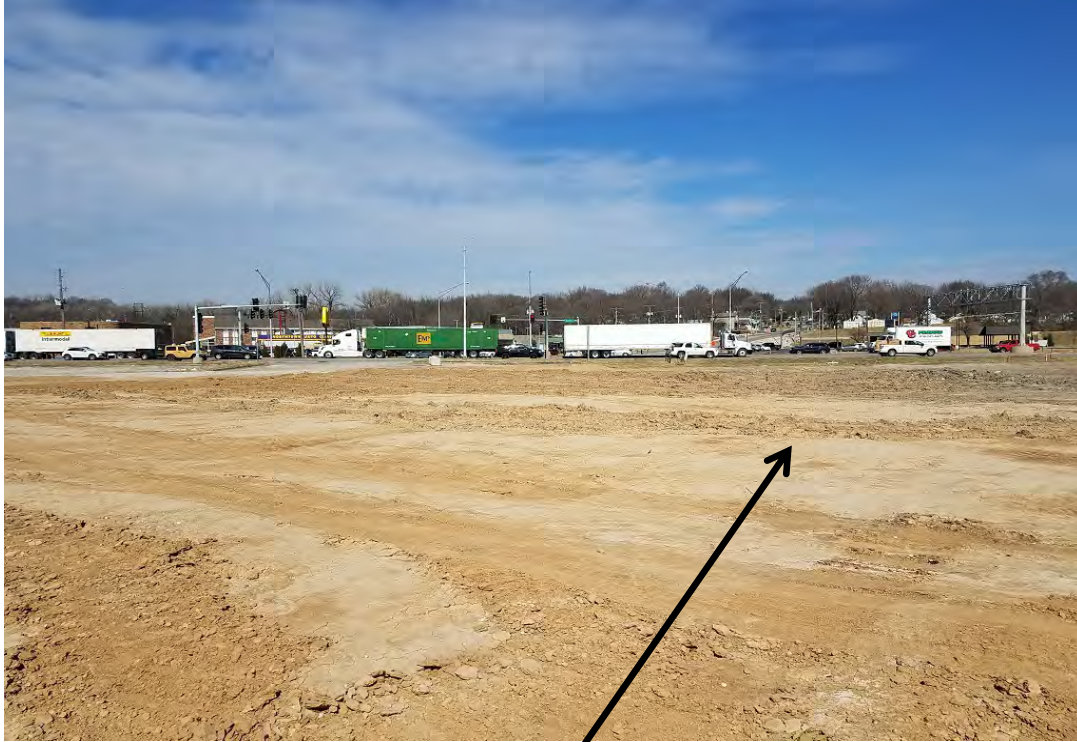
RR avenue soil staging area scraped clean

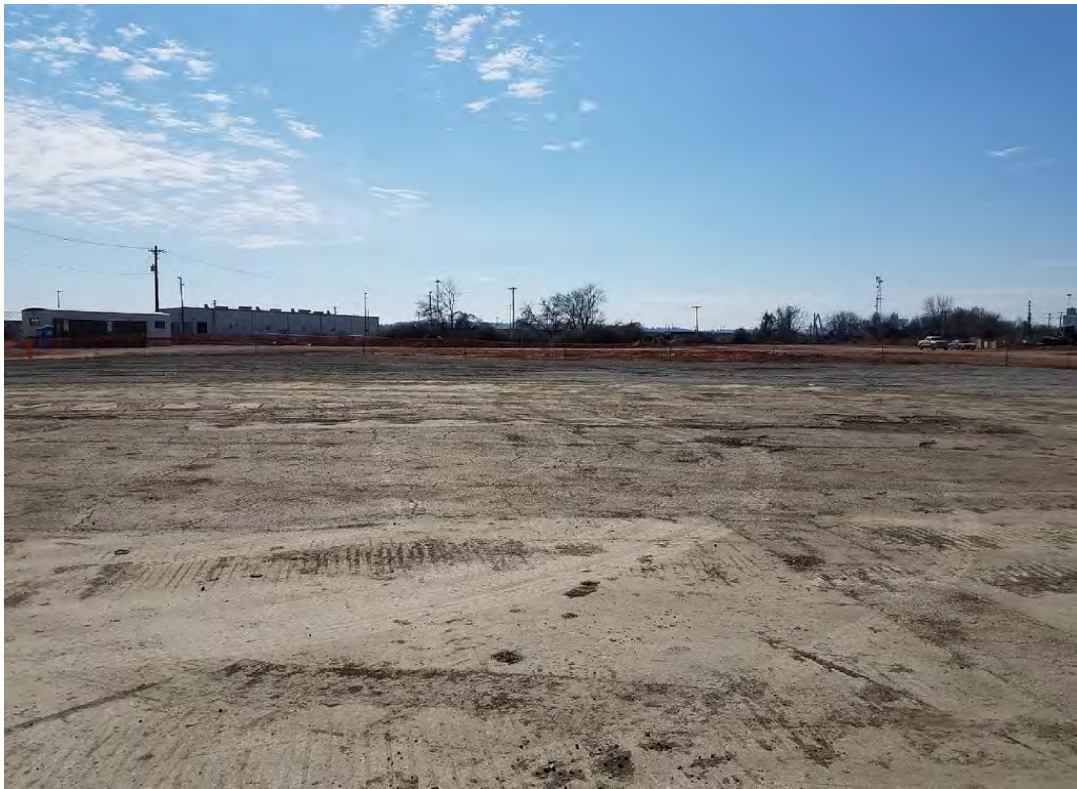
After demobilization, Sutherlands completely backfilled
